MARINE INVESTIGATION REPORT

M03L0026

GROUNDING

THE BULK CARRIER *GREAT CENTURY*
OFF BATISCAN, ST. LAWRENCE RIVER, QUEBEC

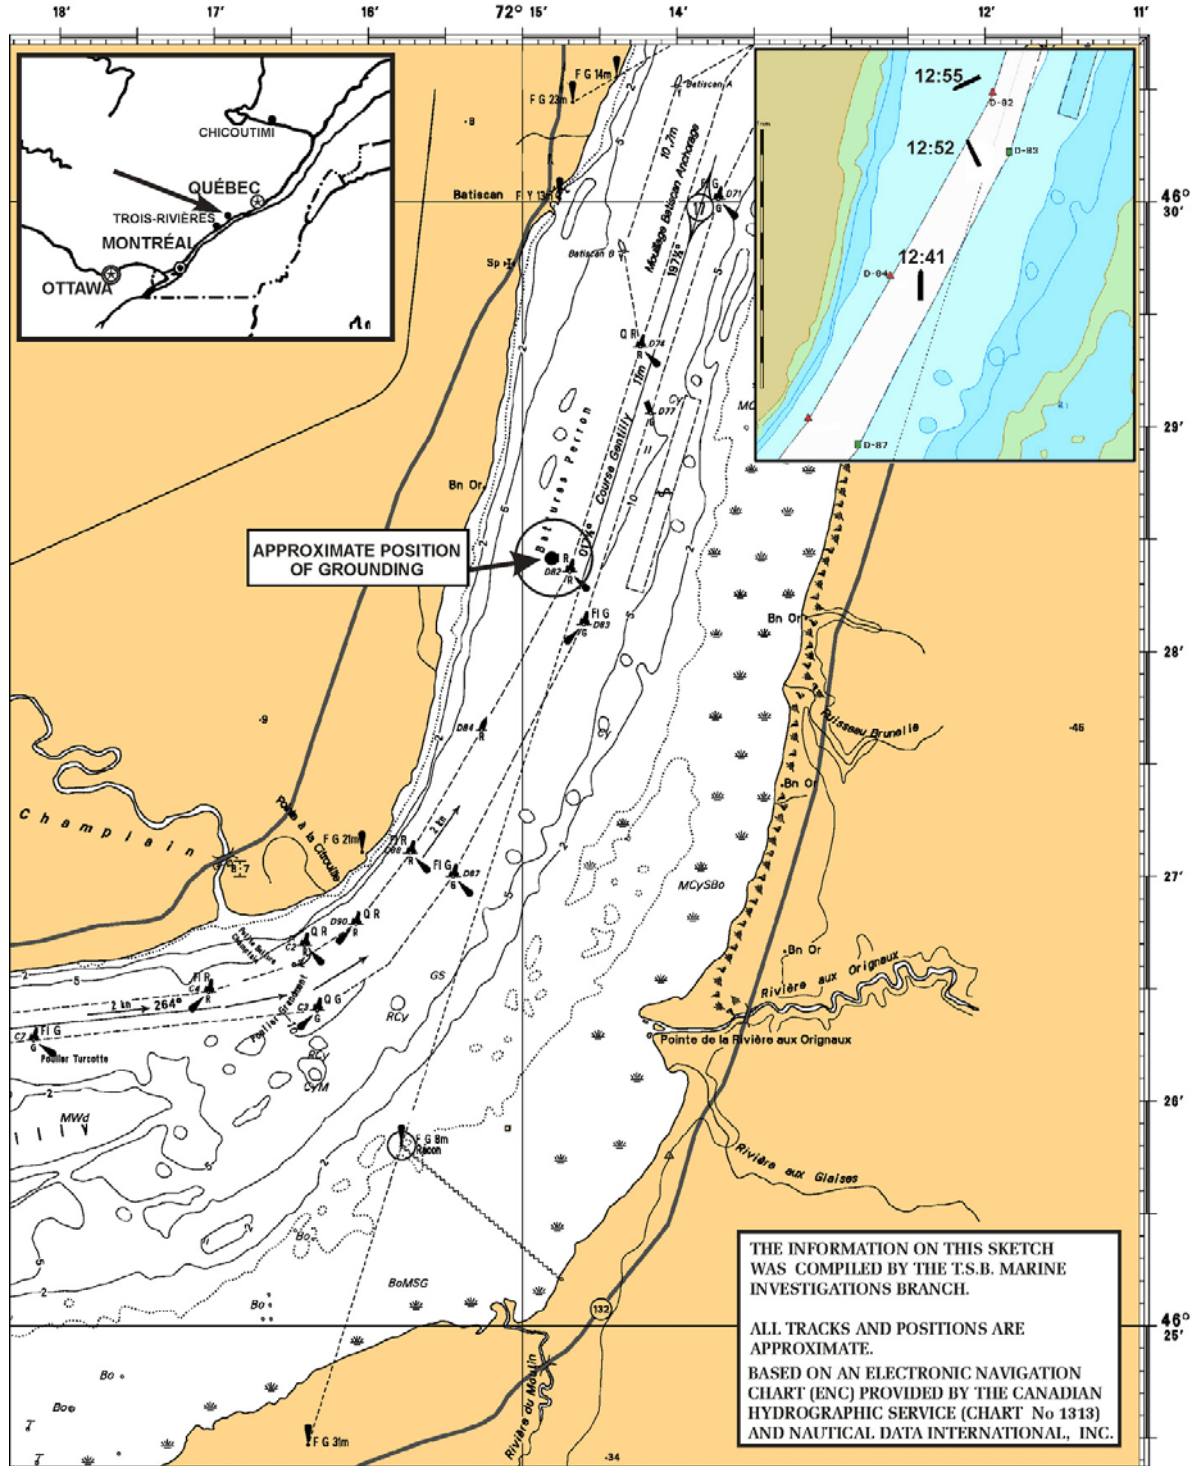
Figure 1. Sketch of the occurrence area

Up until this time, the vessel had continued to use the high sea suction for cooling water. The cooling circuit water pressure, nevertheless, continued to fluctuate and sometimes the flow stopped. The generators were, in succession, brought off line and once cooled, were reconnected in order to maintain the electrical supply.

Thereafter, the vessel returned to the port of Bécancour. An underwater survey of the hull revealed scratch and scuff marks on the paint, and the propeller sustained damage in way of the tips.
